PROJECT ACRONYM AND TITLE: Marine Structural Failures Database (MarStruFail)

Marine Structural Failures Database

1. Ship Structural Failures

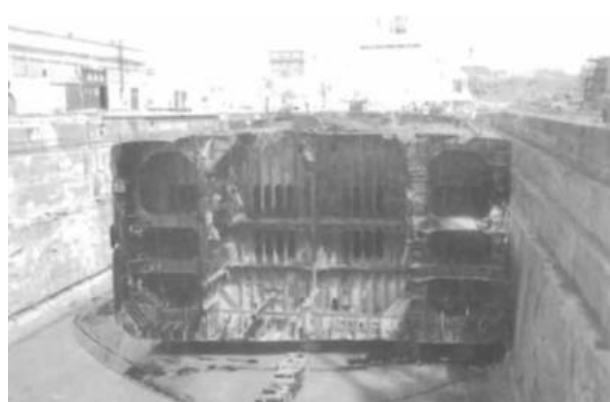
The MV Kurdistan suffered a catastrophic brittle fracture initiating in the port bilge keel weld, which propagated into the ship's structure, causing the vessel to break in two. Despite all the materials tested met the required standards, the inadequately done weld in the ground bar of the port bilge keel induced a large weld defect, thus reducing the local toughness. This weld defect was subject of fatigue damage, increasing the local notch acuity, finally resulting in a brittle fracture as the vessel encountered "head on" seas on emerging from an ice field.

Fig.3 Extent of damage [2.1]

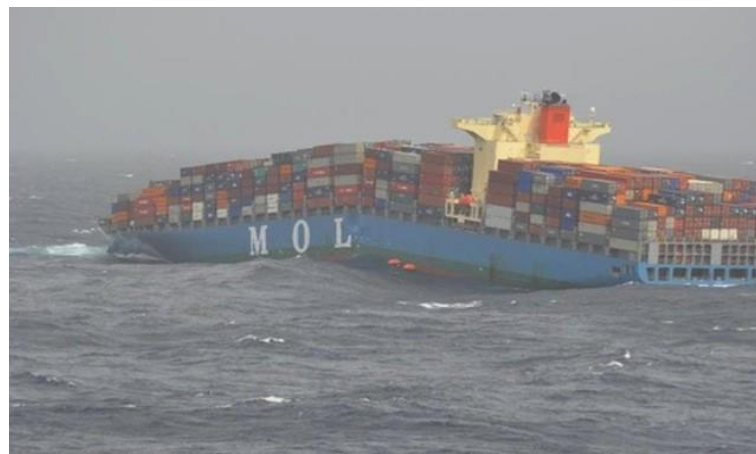
Results of the investigation had shown that the hull fracture originated from the bottom butt joint in the mid-ship part. A possibility that the load's upper limit exceeded strength's lower limit was also estimated using probabilistic approach. Furthermore, safety inspections of the MOL Comfort sister ships have shown buckling deformations (concave and convex) of the bottom shell plating of up to 20 mm (4 mm allowable) in height observed near the centre line.

Fig. 2. Damage extent

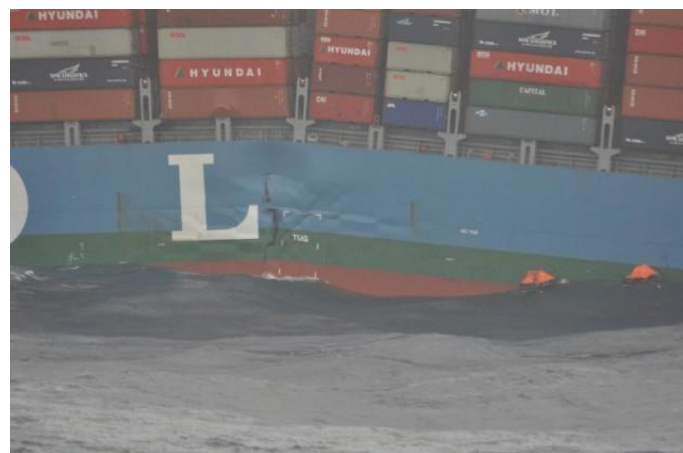
Fig.3 Damage extent (detail)

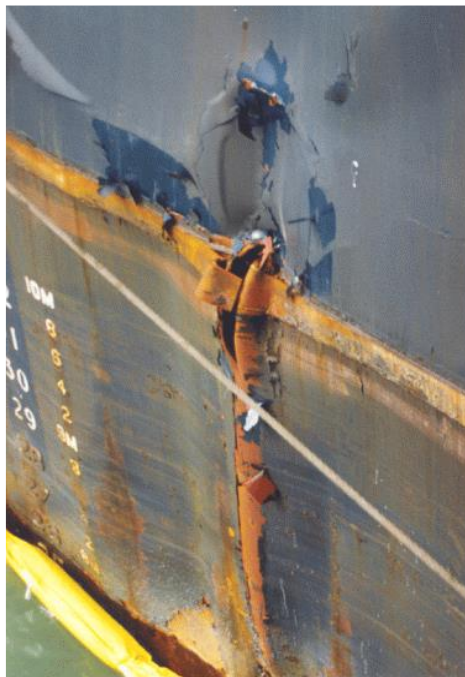
The bulk carrier Algowood experienced a sudden major structural failure due to inadequate loading and de-ballasting procedures. The investigation of the occurrence did not show any material and structural inadequacies nor any kind of uncharted obstructions, boulders, or other features that could have contributed to the initiation of the hull failure. The accident occurred due to inadequate loading sequence causing the appearance of stresses that exceeded nominal values, hence causing a fracture in the hull allowing water to flood the ship.

Fig. 2. Damage detail

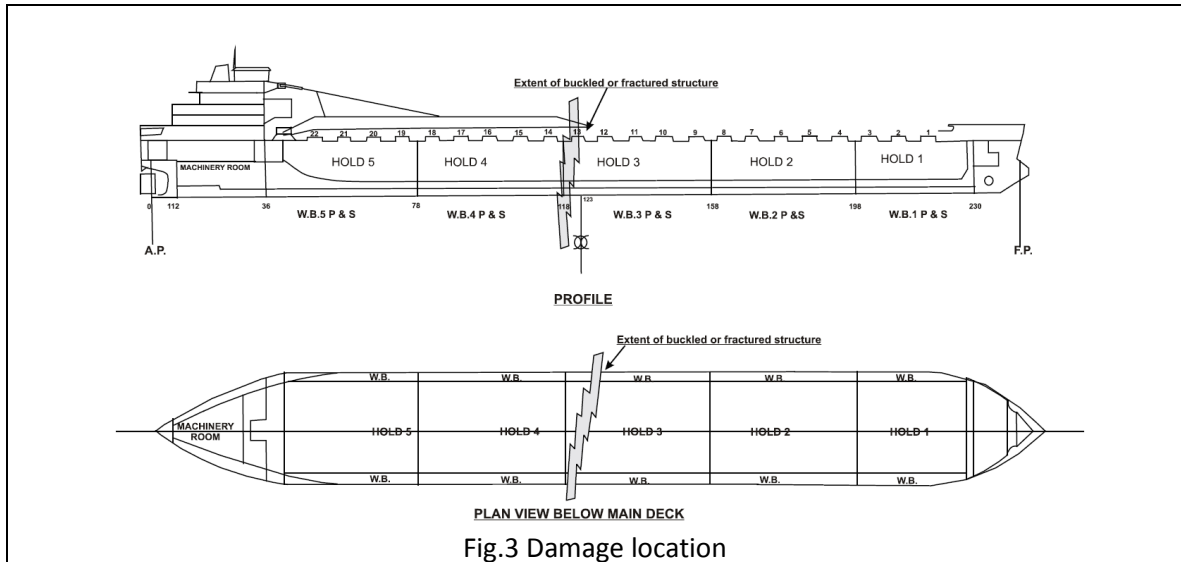
Fig.3 Damage location

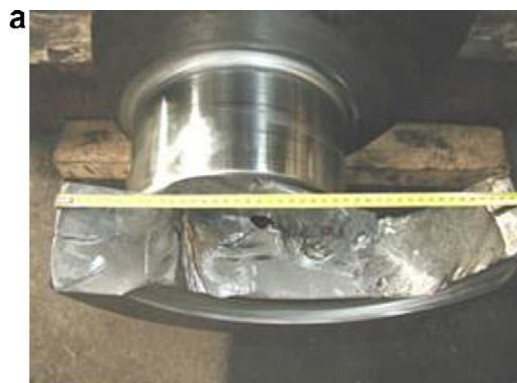
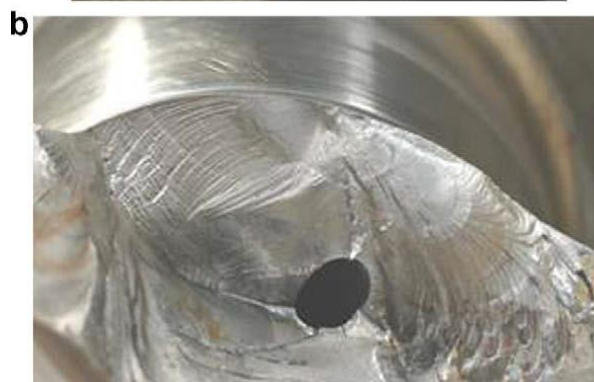
Failure analysis tools and methods used:
Microscopy (eye seen) observation Linear elastic fracture mechanics Micro-fractography
Crack initiation:
On the fillet of the crankpin, starting as three short parallel cracks nucleated by rotary bending.
Crack propagation:
From the web crankpin to the main journal, with a typical helical surface due to the effect of torsion.
Analysis results and conclusions
<p>Crankshaft are loaded with a combination of cyclic bending and steady torsion due to dynamic variations of load conditions of the engine. After a certain amount of working hours, fatigue effects become important. A particular case of a crankshaft that failed after over 32834 h in service, and has broken on one of the web crankpins, in the transition to the main journal is used as a typical example.</p> <p>During visual inspection, a crack in the middle of the crankshaft was found. The fatigue crack surface morphology lead to the conclusion that the fatigue crack initiation was caused by rotating bending stresses and the crack propagated by rotating bending combined with torsional stresses. Lines in the crack surface, known as benchmarks, were noticed. These lines correspond to the engine stopping or changes of loading in service and are helpful to calculate the number of cycles. Micro-fractography revealed no inclusions, pre-cracks, or other abnormal stress raisers. Fracture mechanics approach was used in order to determine the viability of a fatigue fracture. The two distinct surfaces on the fracture (one smooth and the other in a horizontal plane of the crankshaft), the records in the main engine book on board and the examination of the local microstructure close to the crack initiation zone showed that there were no inclusion, flaw or a latent defect in the material that could have caused the failure. Fatigue then remains as a culprit of the failure.</p>

Fig. 2. Fracture details

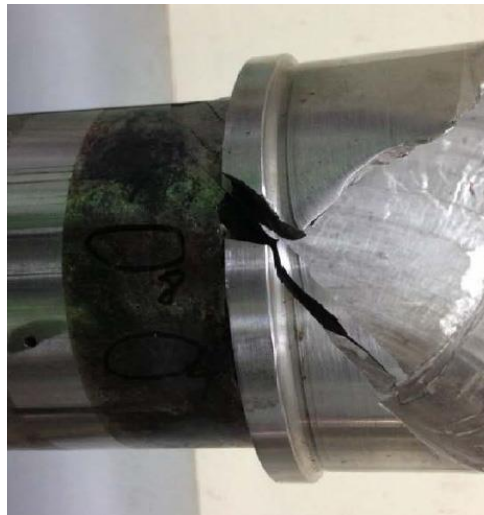
The geometry of the ends of keyways represents a stress concentration factor in the cases of torque transmission through shaft keys for dynamic vibrational loads. Faulty machining of shaft key elements (key groove, keyway and key) geometry, inadequate run out radii or material imperfection can be root causes of torsional fatigue failure in shaft keys. The characteristic torsional failure indicator is the crack pattern that initiates at the end of the keyway and propagates in a 45° rotational direction in a helical shape.

Fig. 2. Shaft crack detail

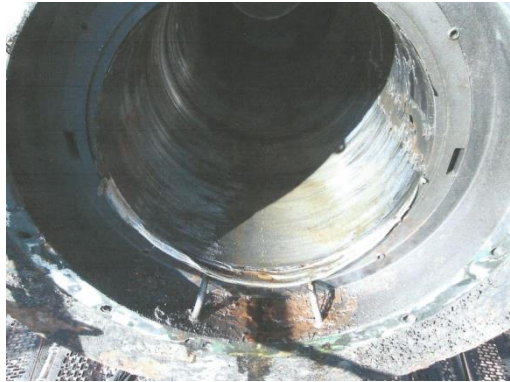
Causes of damage: overload of stern tube bearing caused by additional hydrodynamic forces; lack of proper lubrication due contamination with water and not enough lubrication oil pressure; fatigue of the stern tube bearing. Nevertheless, origin cause is neglect of the bad shaft line alignment (9 years).

Fig. 1. Condition of aft and fore of stern tube bearing

- Shaft line alignment and crankshaft springing should be checked periodically or the structural health monitoring system should be installed.

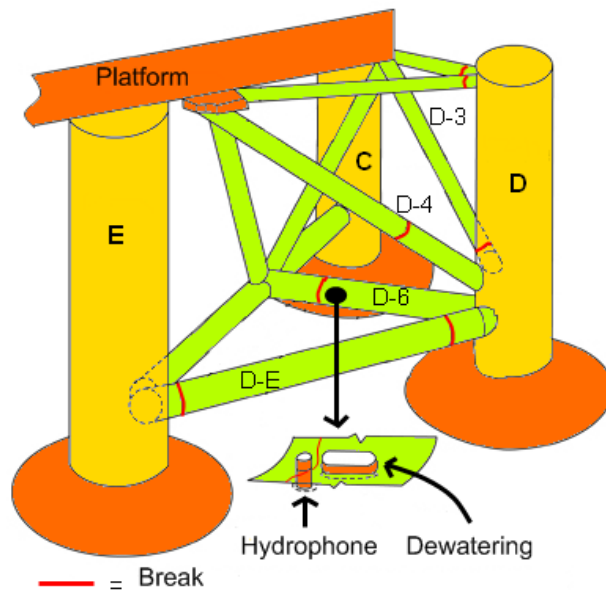
It was determined that the fatigue fracture initiated in one brace (designated "D6") from pre-existing cracks in the welds between a hydrophone support and the brace, then a final ductile fracture of the brace occurred which caused plastic collapse of the remaining five column braces. Material analysis has shown poor ductility characteristics through the thickness of the material.

Fig. 2. Fractures on the rig

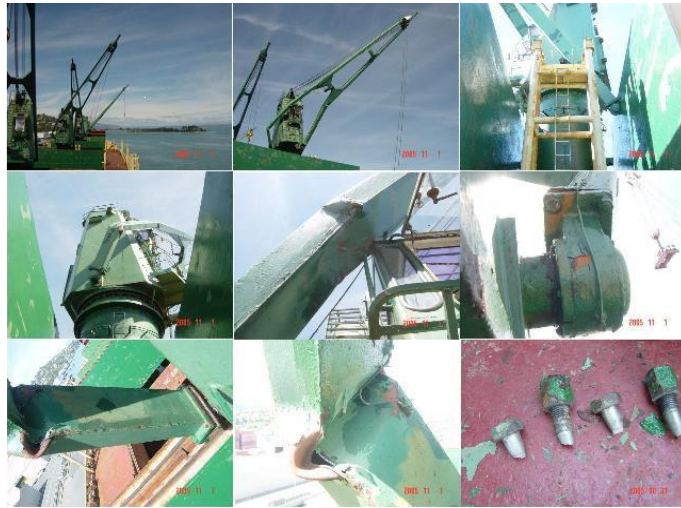
On October 31st 2005 whilst Sea Angel was loading logs at the port jib arm of a hydraulic crane detached from the crane's heel pin, causing serious damage to the jib of the crane. There were no injuries. The subsequent investigation has found severe negligence during inspection and maintenance activities, as well as non-adequately dimensioned heel bolts that proven critical for certain crane operations. Possible pre-existing cracks were found on the bolts indicating that this particular accident has been caused by a combination of poor maintenance and fatigue.

Fig. 2. Failure details

- The importance of inspection & maintenance requirements/recommendations
- The importance of adequate information circulation and feedback information in and from exploitation
- The importance of crew education in recognizing and assessing equipment condition and behaviour during exploitation

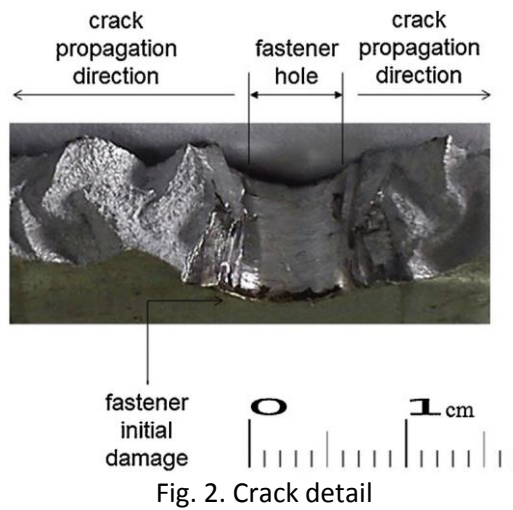
Visual examination of cracked steering wheel revealed machining and fretting marks on the surface of fastener hole from which cracks emanated. These marks served as initiation points for crack growth.

Detailed SEM examination of the fractured surface confirmed cracks growing from the mentioned marks and showed direction of crack propagation to be through the thickness of steering wheel and toward the outer edges. Fracture area consists of dimple fracture and transgranular cleavage separated by crack gaps near the fastener hole. Surface consists of some cleavage step pattern that reminds of Wallner lines. Cracks between flat surfaces and cleavage suggest possible fracture initiation point.

Fig. 2. Crack detail
